Forensic investigation of a failed connecting rod from a motorcycle engine

Case Studies in Engineering Failure Analysis

Short communication

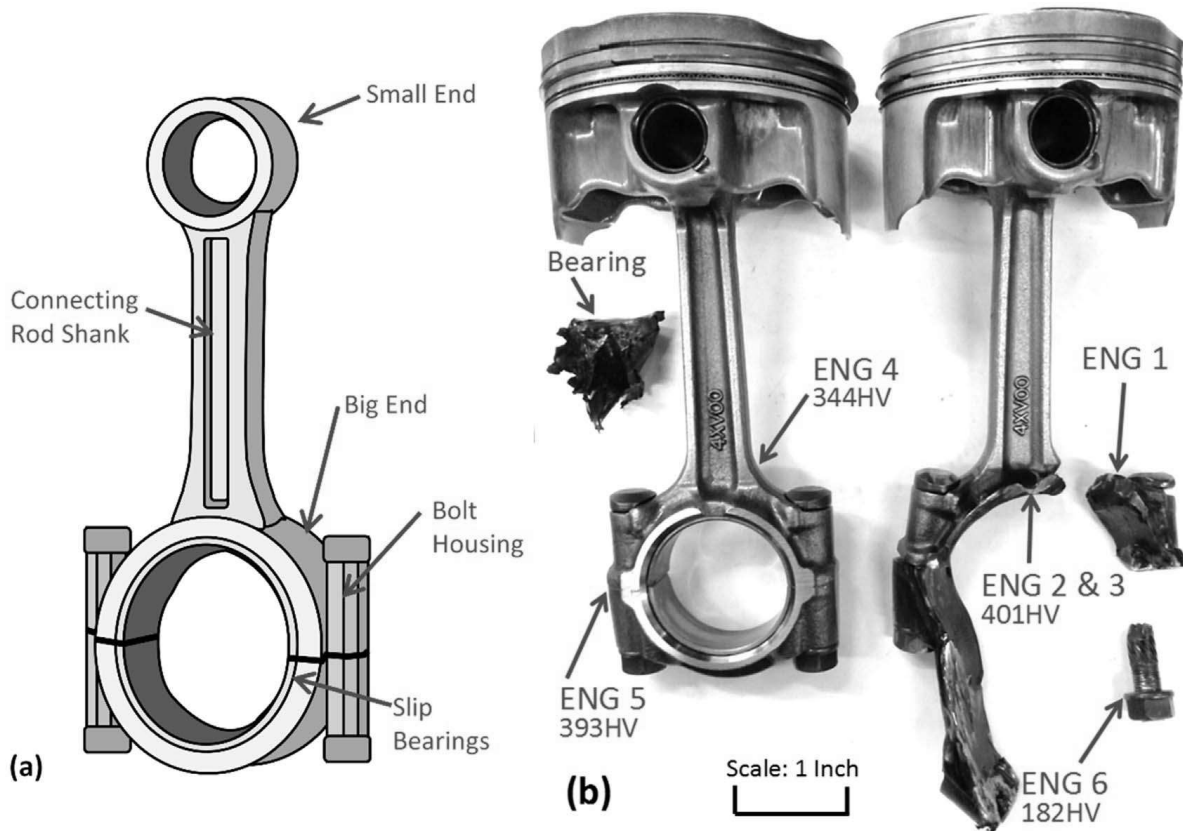
Fig. 1. (a) Diagram of an assembled connecting rod, rod cap, bolts and slip bearing with key features and components annotated in red; (b) The intact and failed connecting rod and piston assemblies, left and right consecutively, are shown with the failure.

in the bolt's hardness, possibly due to a primary manufacturing defect. Lower hardness has induced bolt elongation as shown in sample ENG1 in Fig. 1b. Consequently, bolt plastic elongation has imposed a high cyclic impact stress on the surface of the housing during tension and compression cycles, resulting in twin cracks can be seen in Fig. 8. The rattling noise was detected by EDR before failure and the engine management system has recoded that noise for 5 s before the connecting rod's failure.

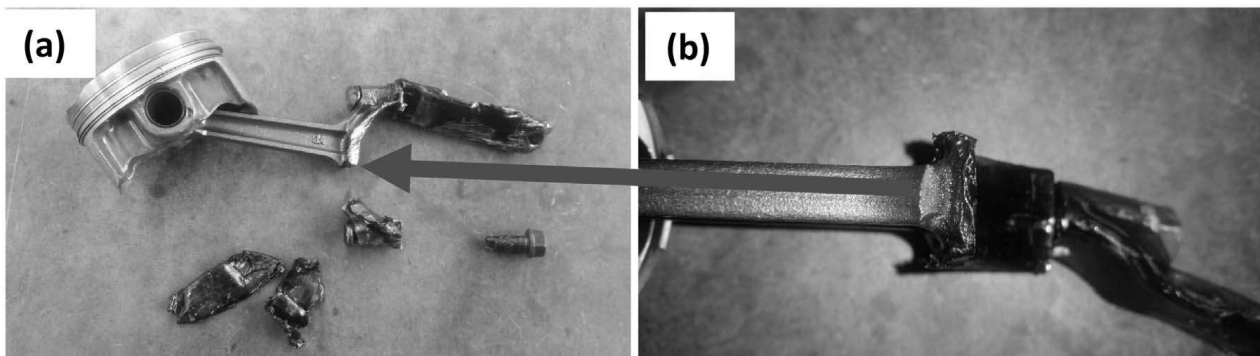
Fig. 2a shows the fracture point at the big end of the connecting rod. The fracture surface, Fig. 2b, is normal to the rod big end. Observation of the fracture surface reveals discoloured area due to excessive heat. The rod big end is blackened and it should be noted that the slip bearing is no longer a separate piece; it has melted into the big end journal. The rod cap is plastically deformed as shown in Fig. 2a. The plastic deformation is due to heat build-up during operation, causing a drop in yield strength.

Fig. 2. Photographs of the failed connecting rod: (a) Fractured rod shank and big end, fractured rod bolt, deformed rod cap, and melted slip bearing; (b) A closer look of the fracture point highlighted by the red arrow.

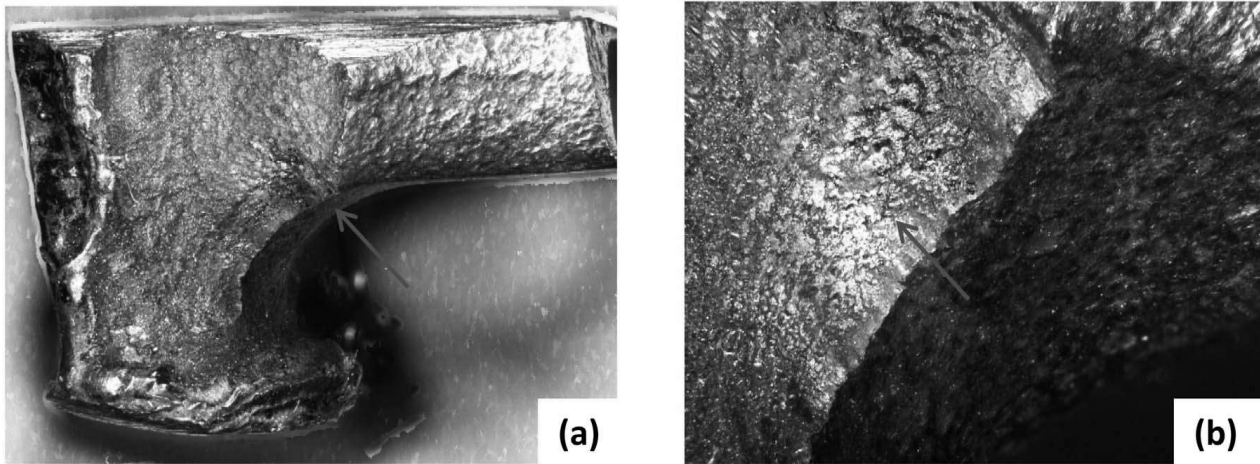
Evidence of heat tinting was found, suggesting that thermal hotspots inside the material were a contributing factor to its failure. The blue sections represent a temperature of around 330 °C, the violet represent temperatures of approximately 280 °C, and the yellow areas represent temperatures ranging from 210 °C for the lighter shade to 240 °C for the deeper shade, as seen in Fig. 3 [2]. The red arrow in Fig. 3a indicates the fracture point in the big end of the connecting rod, some of the Marco beach marks are appeared to be perpendicular to the red arrow in Fig. 3b.

Fig. 3. Digital microscope images of ENG1: (a) Digital microscopy reveals heat tinting marks on the fracture surface; (b) Close up showing heat tinting near surface which suggests crack initiation point indicated by the red arrow.

The maximum tensile load, which is essentially the inertia load of the piston assembly mass, occurs after the exhaust cycle is completed and a vacuum created in the combustion chamber. It was observed that at high engine speeds, the maximum tension stress in the shank bottom does occur at the top dead centre (TDC) [6]. It was also observed that the stress magnitude varies with location and engine speed. The maximum bending stress over one engine cycle at the shank centre was found to be about 25% of the maximum stress at that location. The fracture point shown in Fig. 3b matches the location of the maximum stress at the big end shown in Fig. 9.

- It is concluded that the connecting rod failed on the end of exhaust stroke, primarily due to fatigue loading.
- Based on FEA, the maximum bending stress at the shank centre over one engine cycle was evaluated to be about 25% (75 MPa) of the maximum stress (300 MPa). The actual fracture point shown in Fig. 3 matches the location of the maximum stress at the big end obtained from FE simulation.

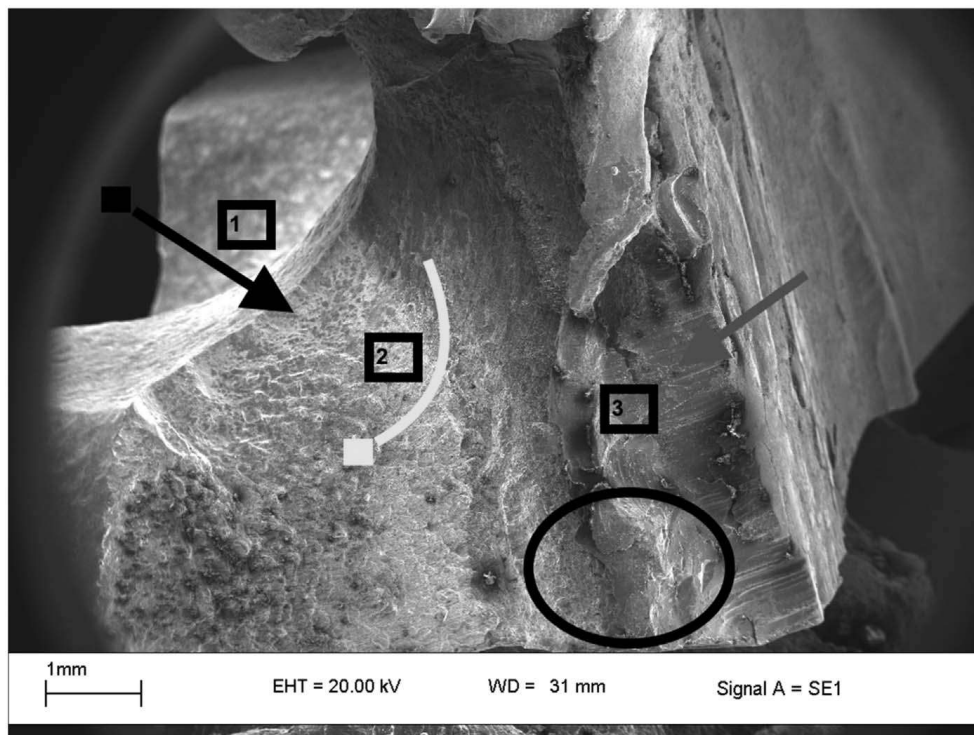
Observation of the fracture surface, using an SEM at the lowest magnification, presents key topographies to understanding the cause of fracture including; crack initiation, crack propagation, and a fracture plateau. Beginning with the region 1, shown in Fig. 4, the geometry of the fracture reveals the direction of shear and suggests a multiple ratchet cracks were initiated. During operation, the micro cracks grow to major ratchet crack through the sulphide brittle phase in region 1 as shown in Fig. 5a. In region 2, circular micro cracks (striations) can be seen, highlighted in Fig. 4, as yellow subtle circular beach marks. The direction of the circular beach marks agrees with the direction of crack propagation from the initiation site in region 1, towards the fracture plateau (region 3).

In region 3, The fracture plateau marked with the red arrow in Fig. 4, shows morphology that suggests a brittle fracture mode [3]. In a fatigue fracture, the final stage, catastrophic failure, is characterized by a rapid brittle fracture as shown in Fig. 5b, which is a high magnification of the black circle in Fig. 4. the transition area from beach marks (region 2) to brittle fracture (region 3) is

Fig. 4. SEM image of the fracture point in ENG-1.

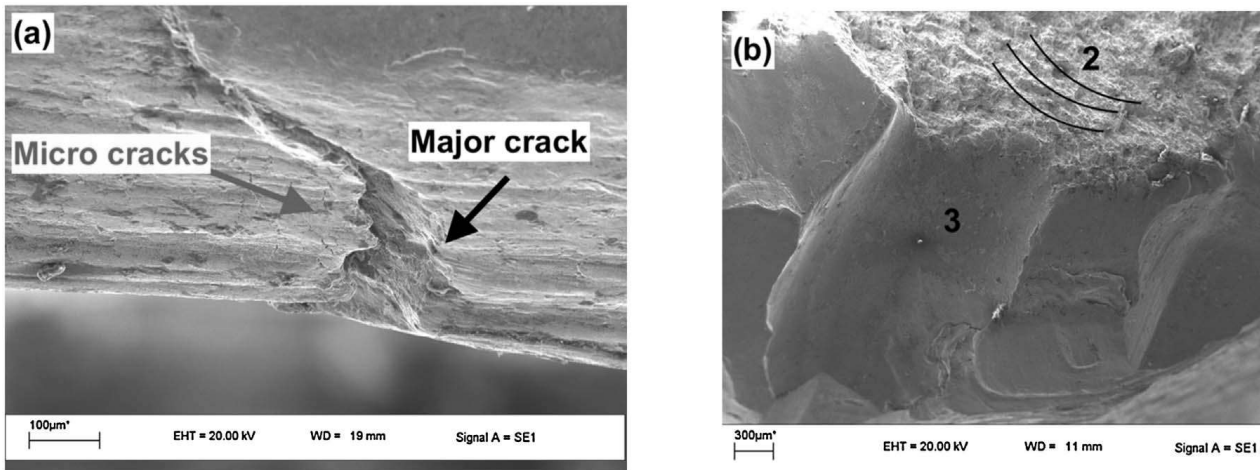
highlighted in Fig. 5b.

Fig. 5. (a) SEM image of fracture surface showing region 1 as a crack initiation in form of major and micro cracks. (b) High magnification SEM image of the black circle in Fig. 4 that shows the transition area between region 2 and 3.

- Fatigue failure of the failed connecting rod demonstrated in term of ratchet marks (region 1), striations/beach marks (region 2) and fast brittle fracture (region 3).

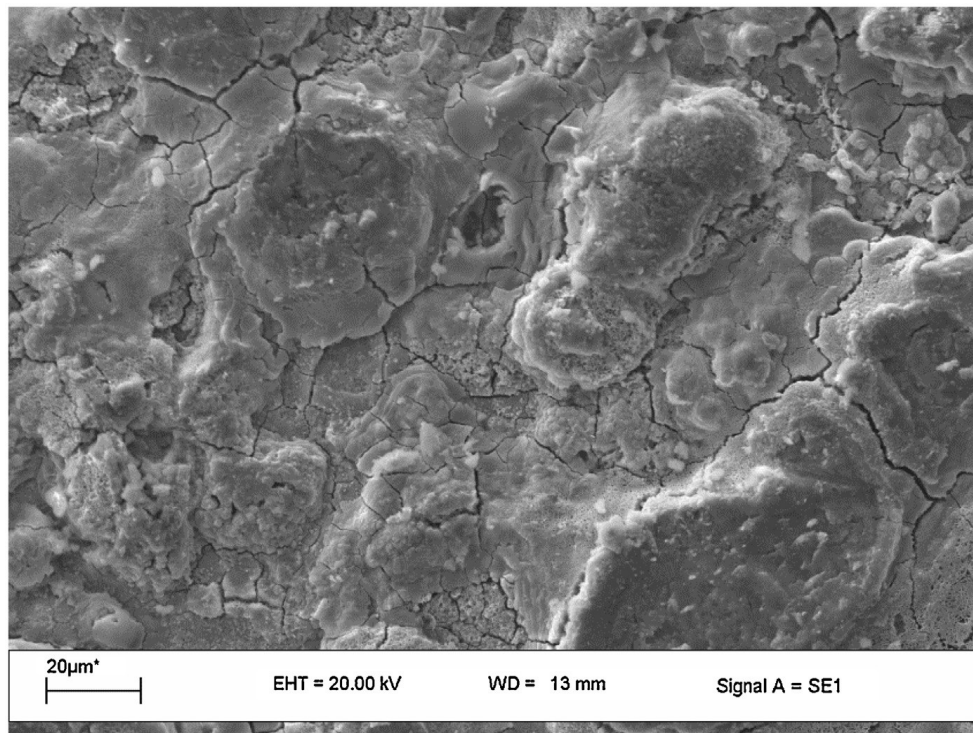
Further magnification of surface SEM imaging shown by Fig. 6, reveals the mud-type micro cracks that exist on the surface of the connecting rod. These cracks were initiated from sulphur-rich iron scale that build-up during environmentally corrosion process, creating sulphide brittle phase inclusion [4]. The brittle sulphide phase leads to the creation of the micro cracks that highlighted in Fig. 7. The EDX analysis of sample ENG2 shows a high sulphur content on the surface of failed and the intact connecting rods (sample ENG4). On the other hand, no sulphur was detected in the fracture regions 1, 2 and 3. This could be either the engine’s oil has been sulphurized due to a sealing defect in the cylinder or the procedure for refurbishing the connecting rod were not hygienically performed.

Fig. 6. SEM image shows of the micro cracks that appeared near the fracture surface.

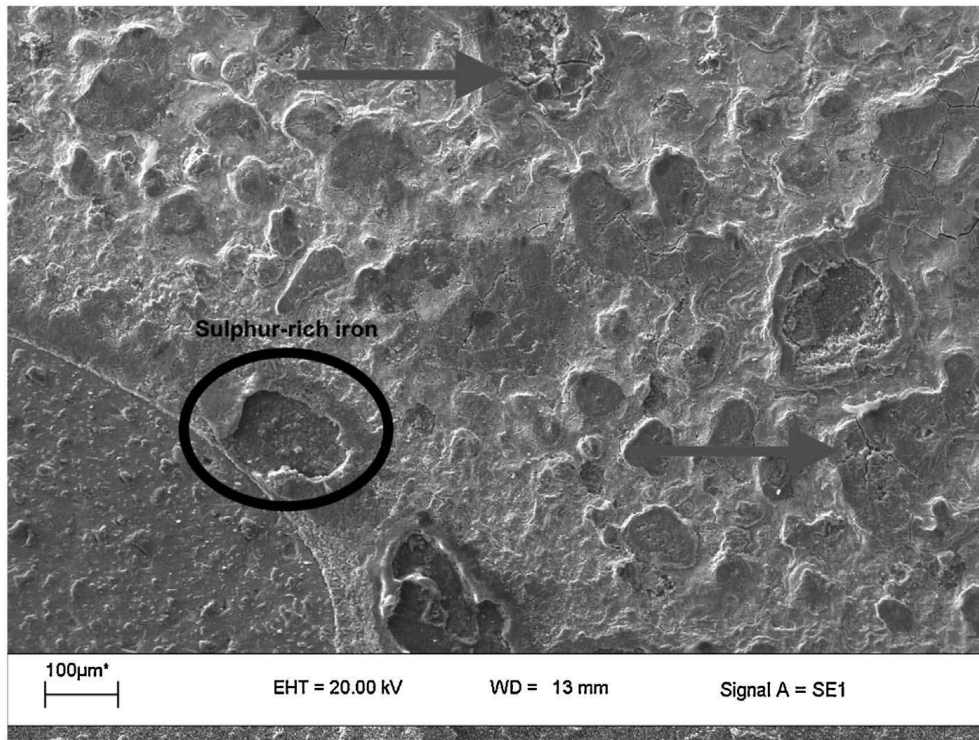
Fig. 7. SEM image shows the sulphur-rich iron scale inside the black circle and microcracks (red arrow) were initiated due to the brittle sulphide phase.

- The scale build-up of inclusions on steel led to micro crack formation that propagated during fatigue loading until the part failed suddenly.
- Observation of the fracture surface reveals sulphide brittle inclusions due to either sulphurized oil or inappropriate refurbishing process.

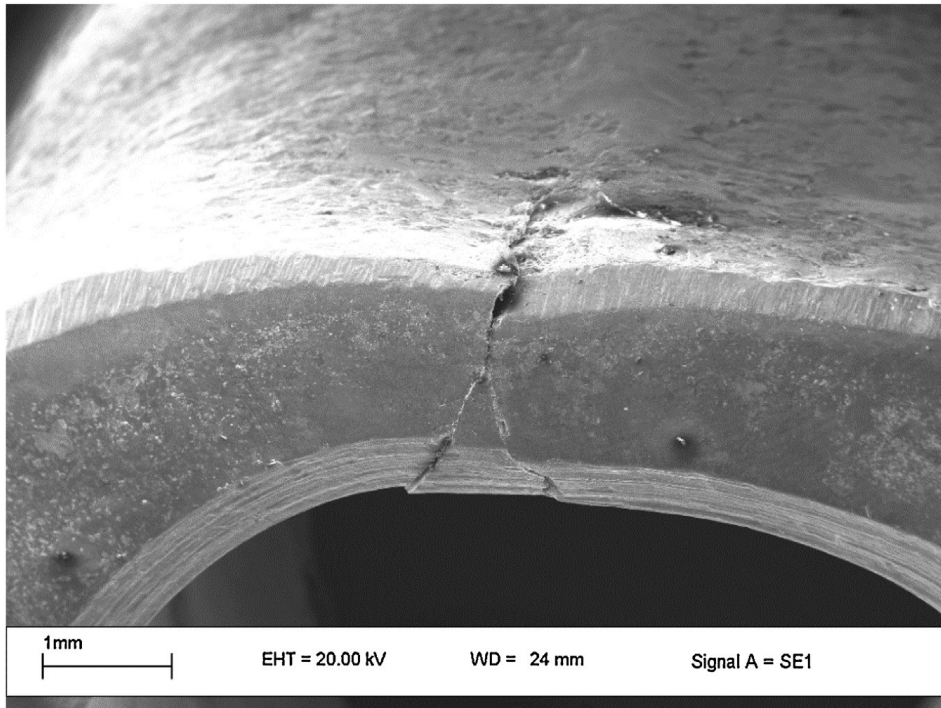
Fig. 8. SEM image shows twin cracks in the bolt housing in ENG1 due to bolt defect.

- One of the bolt has a lower hardness than others, which result in excessive elongation during operation and imposed a cyclic impact stress on the journal's surface. The noise was detected by EDR before failure and the engine management system has recorded that noise for 5 s before failure.

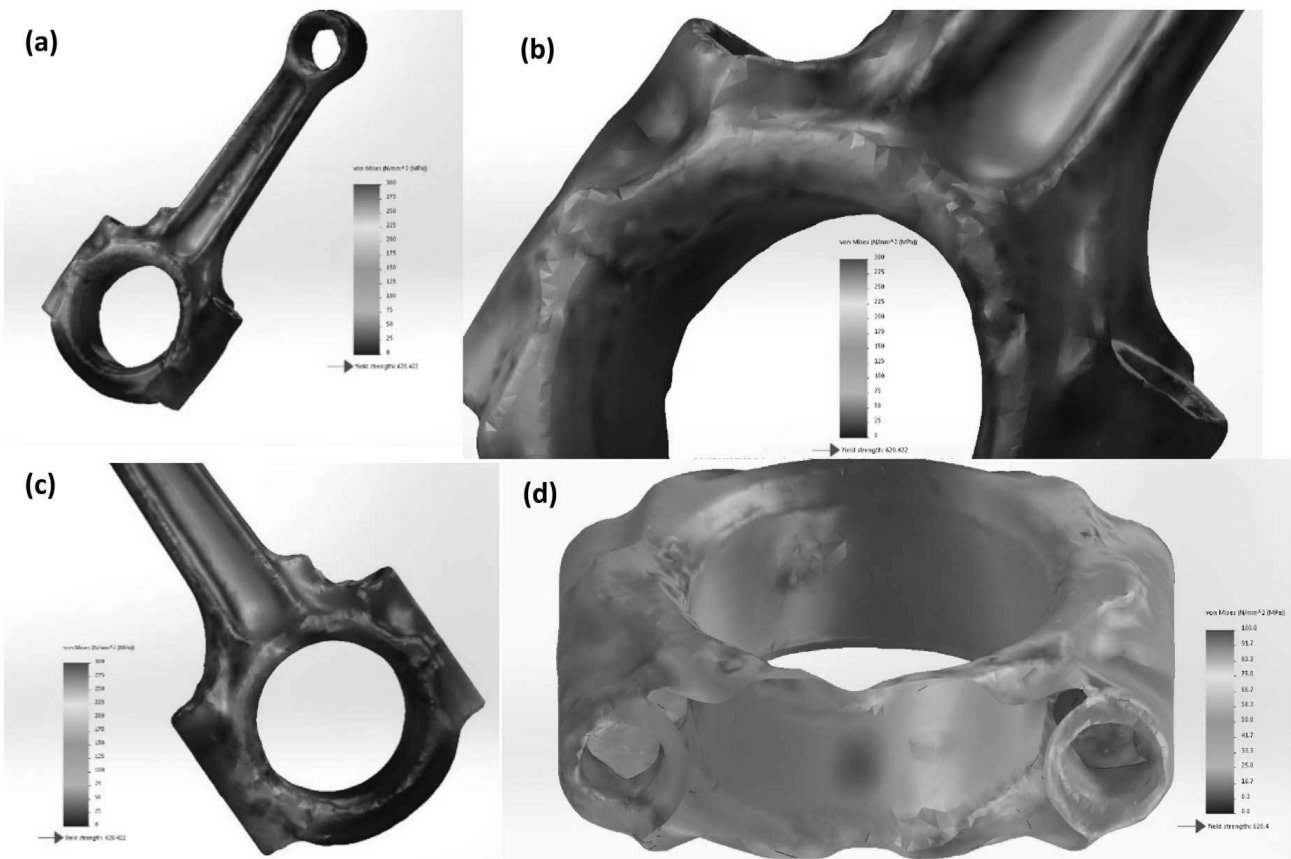
stress. The stress analysis in Fig. 9a shows that, as expected, the maximum stress region (300 MPa) in the model matches the fracture location, located between the big end and the shank. Fig. 9b and c show that average tensile stress at the fracture point was 195 MPa, far below the yield strength of alloy steel, meaning the fracture occurred due to fatigue failure. Fig. 9d shows that maximum tensile stresses were located on the surface of the big end, which confirms that surface cracking was the main cause of the failure. Fig. 10 shows the statistical fatigue strength of low alloy steel AISI 4140 vs fatigue cycle number obtained from Cambridge Engineering Selector software. The line intersecting the band in Fig. 10 shows the probability of the fatigue failure from one million cycles onward in a service operation at cyclic tension stress of 195 MPa. The fatigue S-N curve, however, does not consider material imperfections nor the direction of the acting stress on crack growth [7,8].

Fig. 9. Von-mises stress distribution from FEA simulation: (a) Front view of entire connecting rod; (b) Close-up of big end showing high stress concentration; (c) Rear view of connecting rod big end; (d) Cross sectional view of the connecting rod big end.

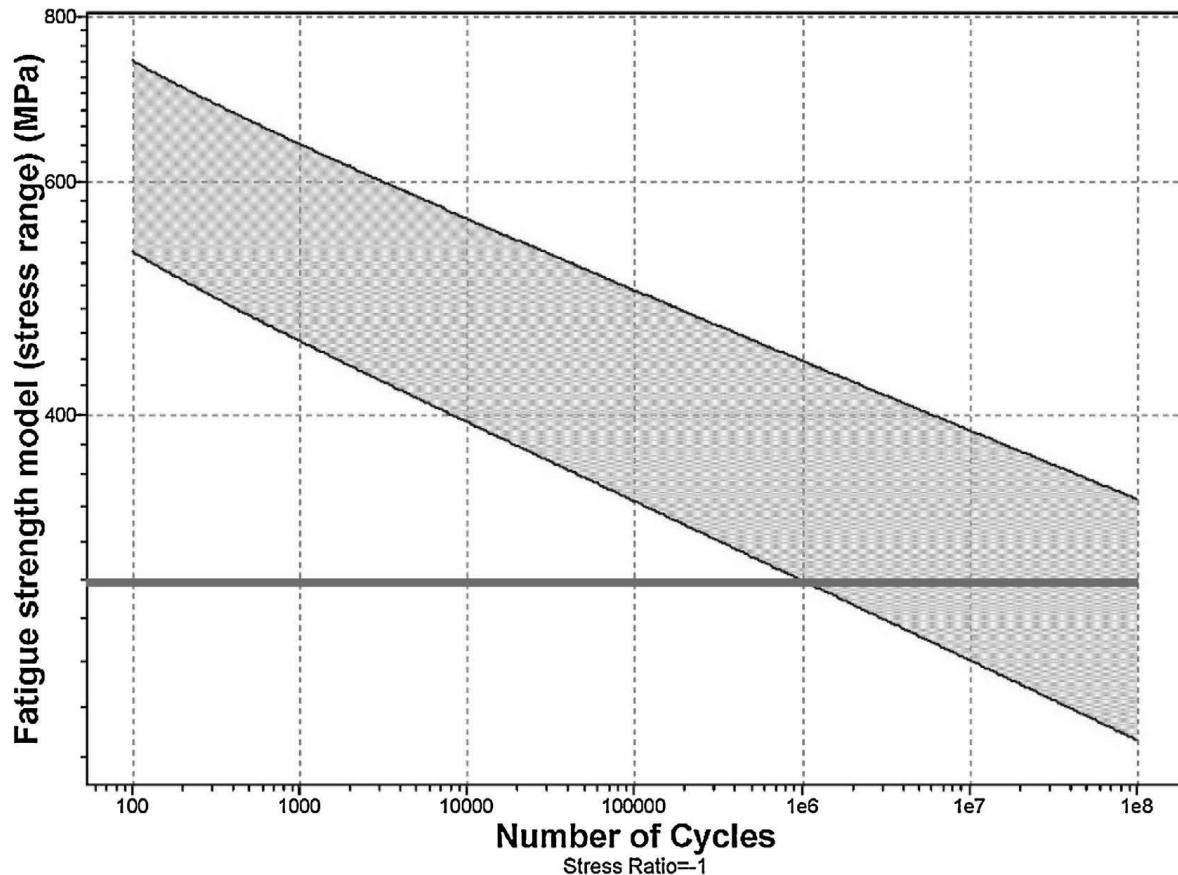
street and not race applications, therefore the life expectancy was shortened when the engine was swapped into the Global GT1. Therefore, it had to power a different, heavier chassis. The estimated safe service life of the material at 11,000 RPM is at least 90 min according to the one million fatigue cycles obtained in Fig. 10. The sequence of failure modes of the connecting rod are as follows:

Fig. 10. Graph shows the relationship of probable fatigue strength vs fatigue cycle of Low alloy steel AISI 4140 [5].
